2018

Nature Island Resort Environmental Assessment

KAMPOR Analytical

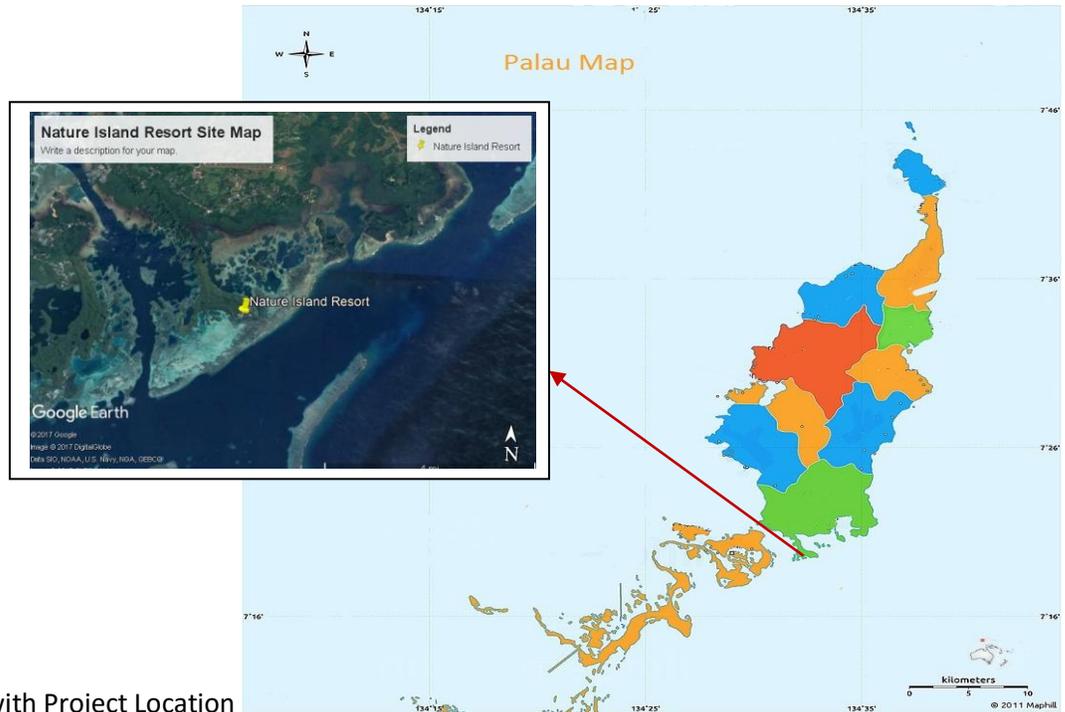
Fig.1: Palau Map with Project Location

The project is located on Ngellil Island, also known as Toshi Island, which is part of Ngerusar Hamlet and lies southeast of Airai State (Figure 1: Project Location). The project is within both private and state land. The Proponents have a land use right for the private land in addition to an agreement with Airai State Government for the use of public land. The Proponents provide needed service to Airai State Government in advancing community eco-tourism activities in the “*Metuker Er A Bisech*”. This agreement mandates Proponent to help establish, operate and manage attraction facilities, including providing safe guided hiking trails for twenty five years. The proposed project will provide the Proponent with a business opportunity that is in line with both Airai State and the Palau Responsible Tourism Framework. The Proponents will play an essential role to ensure that “*Palau’s visitor experience is the living brand and that responsible tourism practices reflect optimal retention of revenue in the local economy*”⁷.

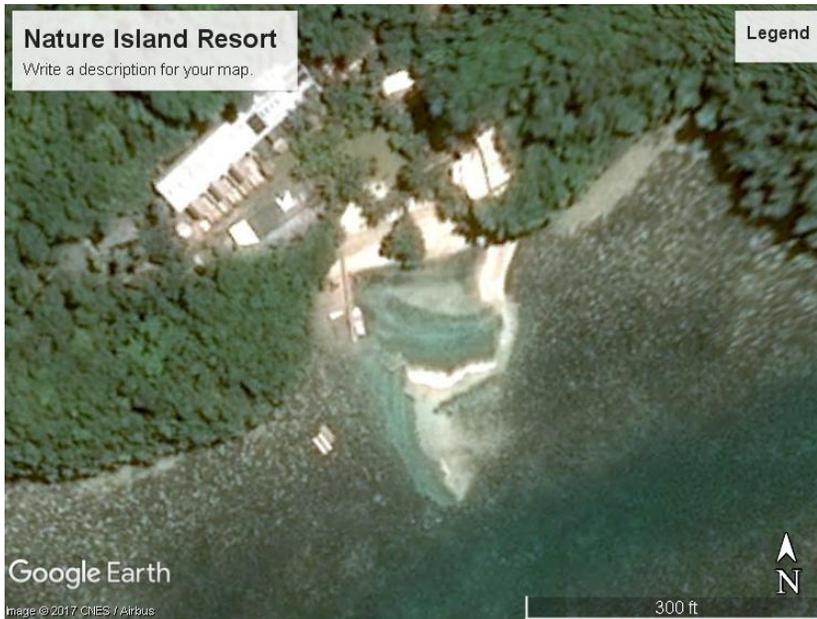
Fig. 2: Site Map showing developed project.

The proposed project site is located at Ngellil Island situated southeast of Airai State, within both private and public lands (Appendix A-1 and Appendix A-2 Land use rights).

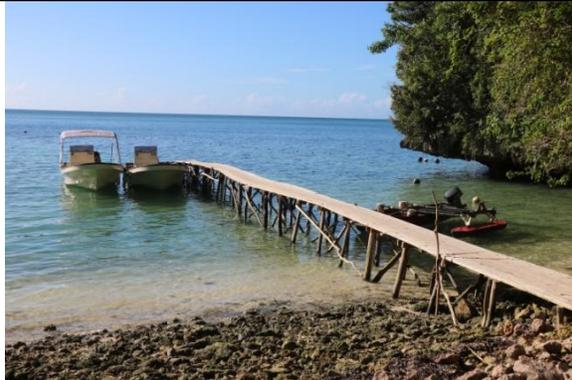
Wooden Pier (3 ft. by 100 ft)

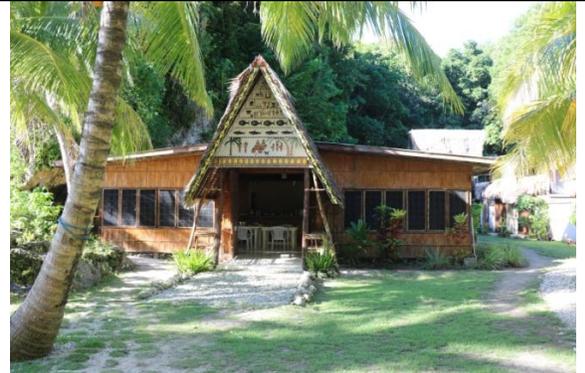
Lobby Area (Remodeled Summer House)

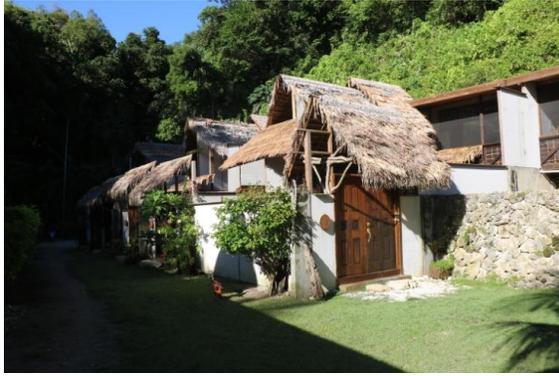
8 rooms originally permitted by EQPB

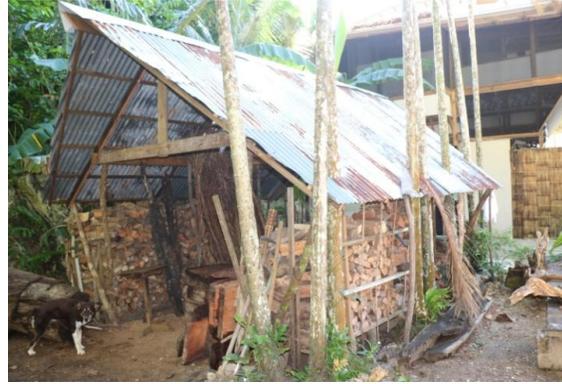
Firewood Shed

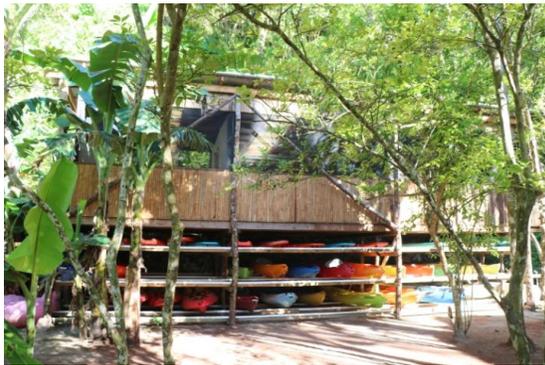
Storage Area/Canoe Shed permitted by EQPB

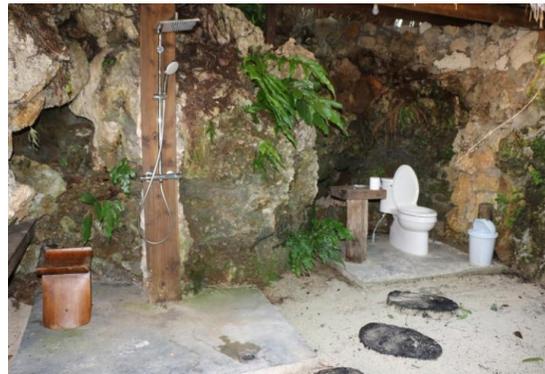
Common Use Toilet and Shower (3 each) permitted by EQPB.

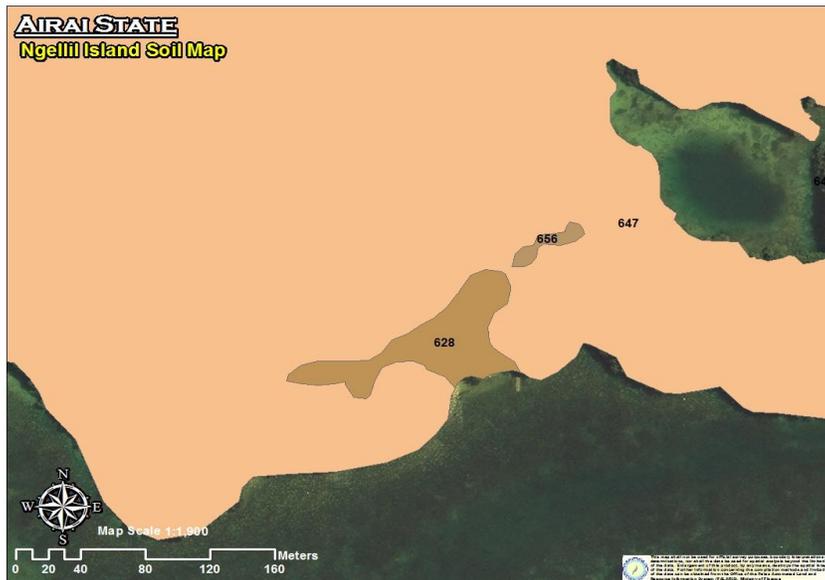
Fig. 3: Soil Map of Ngellil Island

The properties of soils found at the project site, according to USDA Soil Survey are as follow:

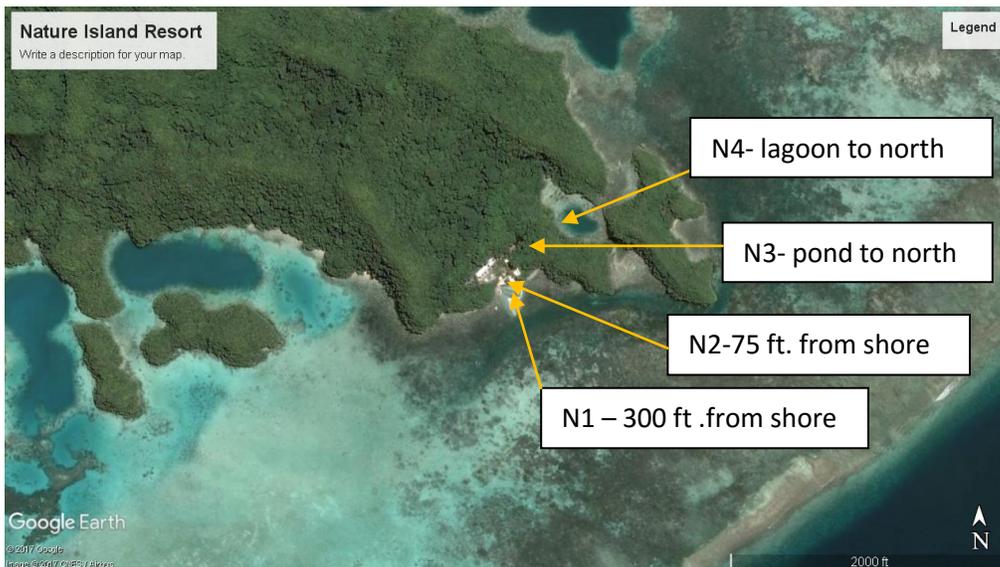
Fig. 4: Water sample sites on January 4, 2018

The project lot is situated on Ngellil Island located at southeast of Airai State. Water in this area would be designated, under EQPB Regulations' water use classification, as Class "A" Waters.

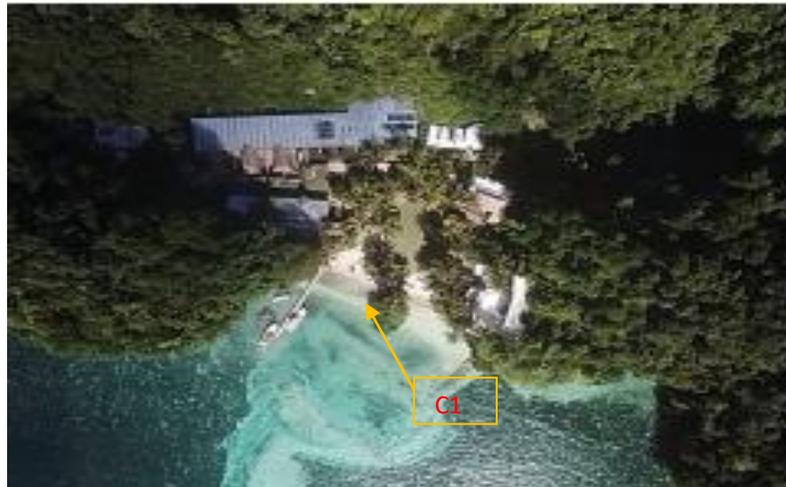
Fig. 5: Map of water current measured on January 4, 2018.

The Palau prevailing wind from the end of November through May was the Northeast to East trade wind. The weather was sunny and clear with wind direction on January 4, 2018 from east to west at 14 miles per hour according to Palau National Weather Service Office. The qualitative analysis of wind-tidal influence on the water pattern was carried out on January 4th. The flow of water current at high tide was measured using a weighted float with a measuring tape to measure distance. The current flow from east headed south as measured at one location in front of resort beach (C1), was at velocity rate of 17 feet per 1 minute.

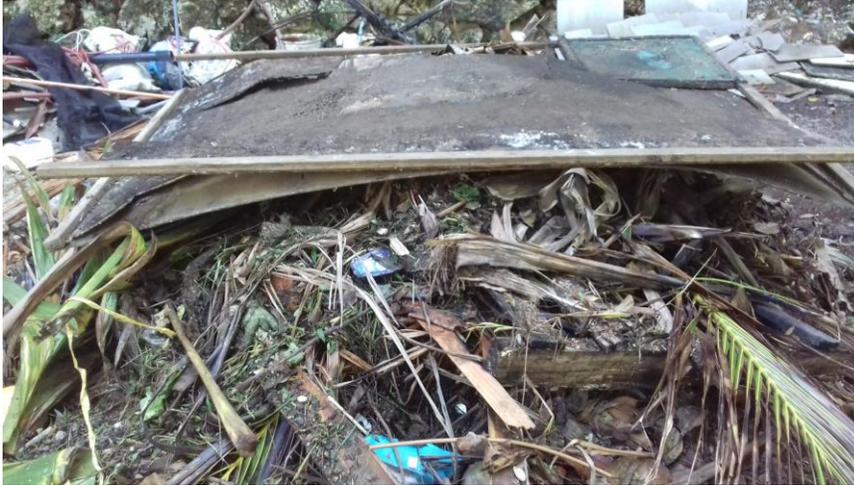
Occasionally the trashes are burnt as part of solid waste management. Due to distance from landfill, the large organic wastes not manageable to compost are burnt on site. The Proponents desired that burning of allowable solid wastes made part of an EQPB's approved permit condition for the Resort's Operation Management Plan. Since its citation for non-compliance, the resort management have been acquiring permit to burn trash about once a week.

Picture of vegetation and wooden trash remain after burning at western part of the resort.

Reduce the impact of air quality by adhering to waste minimization and segregation plan, and only burn trash in accordance to EQPB guidelines and approval.

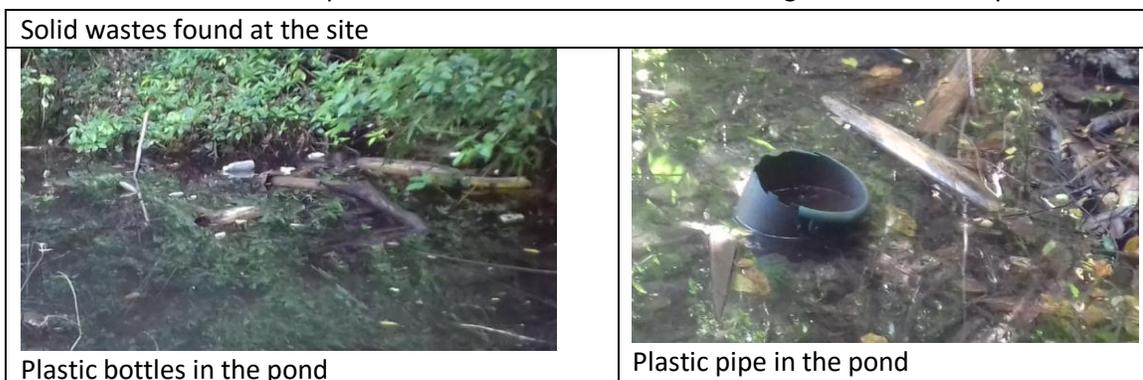
Most of the solid waste generated during the operations of the resort include, plastic bottles, cans, styrofoam plates & cups, plastic forks, spoons, and general refuse. The solid wastes generated daily amounts to one 33 gallon bag.

Photo Plate 1: Pictures of plastic trash found in areas surrounding the resort facility.

It is recommended that Resort Management conduct routine clean ups of debris within the area and the Ngellil island surroundings.

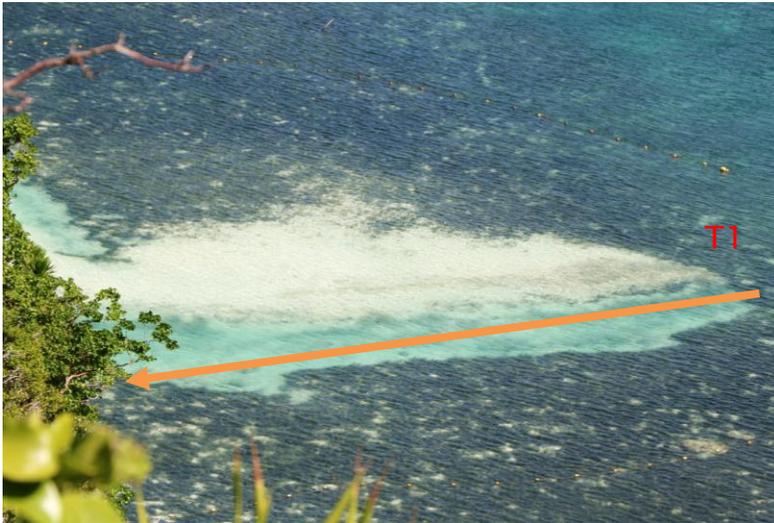
Fig. 6: Map of line intersect, T1.

Visual observations indicate the marine area in-front of the resort beach is mostly disturbed as compared to the 2009 condition assessed by The Environmental Inc (TEI). Two surveys - swim through and a transect survey were conducted from within the dredged (disturbed area) at high tide and in an area as close to transect conducted in 2009. These transects were used to represent the overall composition of the marine ecosystem (see Fig. 6 & 7 Maps above and Table 5: Marine survey checklist).

The first swim through, Transect 1 (T1), was made from the entrance where the floats are located at the distance of about 225 feet and headed straight to the beach. Starting from the entrance and moving inside 50 feet, is a seagrass bed with an estimated over 90% seagrass cover. Only six (*cheuas*) species of sea cucumber were observed in the swim through. After the 50 feet, the reef bottom has been highly altered. The interview of resort staff indicated that a 50 hp engine was used to move the sand to create a deep enough channel for boat access at low tide. The altered bottom is completely made up of sand with sections consisting of rubble materials. Only a school of young Goatfish (bang) was observed at this transect.

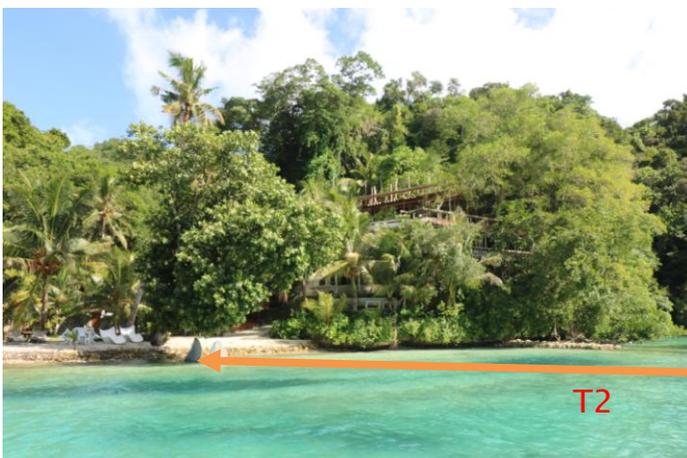
Fig. 7: Map of line intersect T2 as close to July 2009 Transect.

The second survey was conducted using a 75-foot transect that starts on the shore at the base of large *Btaches* Tree and extended sea ward. The line transect area was as close to the same area as the July 2009 transect survey made by TEI. As compared to the 2009 dominated seagrass cover, the current area at the front of the beach has been converted to rubble/sand substrate with few sea grass colony. The surveyed area indicated a highly disturbed area with rolling sand dunes (*cheleliuis*) at the bottom. No fish, sea cucumbers or other sea life was observed in the 75-foot transect. The whole length of transect indicated a bottom substrate of 52% sand and 48% rubbles.

- Time: 9 a.m. to 2 p.m.
- Good visibility
- Wind direction from east to west at 14 miles per hour
- Moderate calm sea
- High tides were 9:16 a.m. at 6.0 feet and 8:45 p.m. at 6.7 feet
- Low tide was 3:05 p.m. at 2.1 feet.

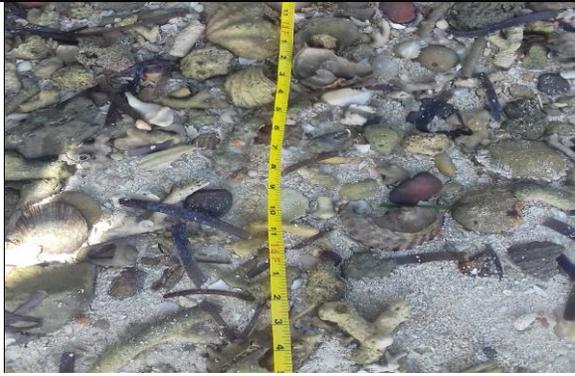
Photo: Substrates originating from beach seaward

Rubbles make up the shore line out to about 16.5 feet.

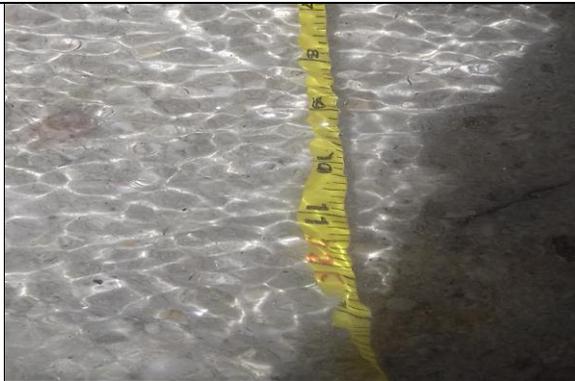
Sand begins at 16.5 feet out toward the sea to about 45 feet.

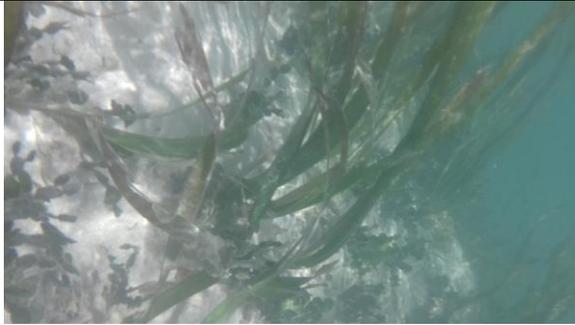
Patches of sea grass are found around 45 feet seaward to about 83 feet where the dredged sand dominates the substrate. This area has changed drastically since 1999. The seagrass density dominated the substrate, starting at 33 feet in July 1999 (TEI).

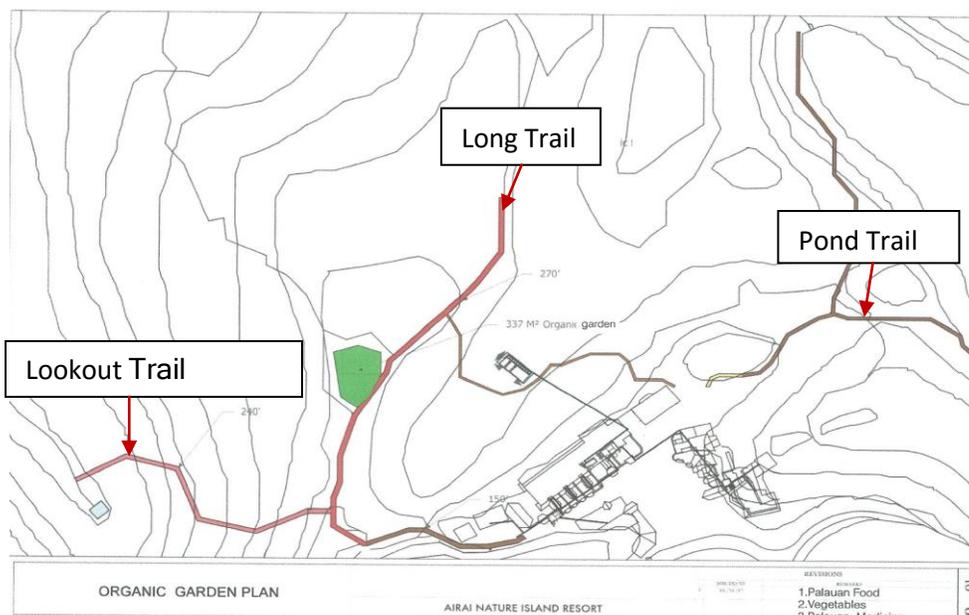
Fig. 9: Map of trails and vegetation survey.

A preliminary walk along the existing nature trails - Pond Trail and Long Trail - was conducted on Dec. 24, 2017. A second walk on January 4, 2018 was conducted for vegetation assessment on all three nature trails - Pond Trail, Long Trail and Lookout Trail. Trees, shrubs, vines and other epiphytes were identified, photographed, noted for their relative distribution, sizes and young plants. The vegetation species along the sides of the trail were identified with local names and scientific names whenever possible. Bird species heard or seen on the trails were also noted (Table 9: Bird assessment on January 4, 2018).

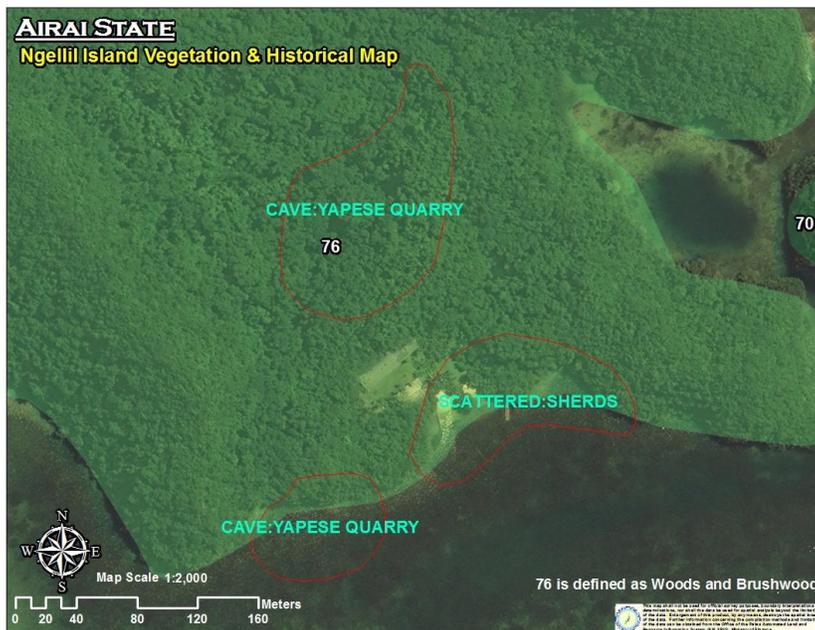
Map 10: Historical Sites and vegetation in south east portion of Ngellil Island.

The Historical map obtained from Palau Automated Land and Resource Information System (PALARIS) shows three historical sites within the southeastern part of Ngellil Island (Map 10 : Historical Sites and vegetation in southeast portion of Ngellil Island). One of the sites, identified as Scattered: Sherds encompasses part of the resort development areas.

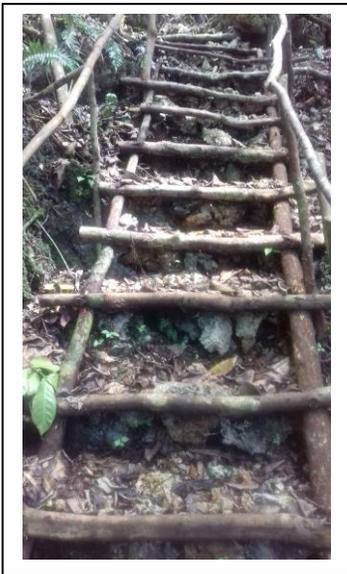
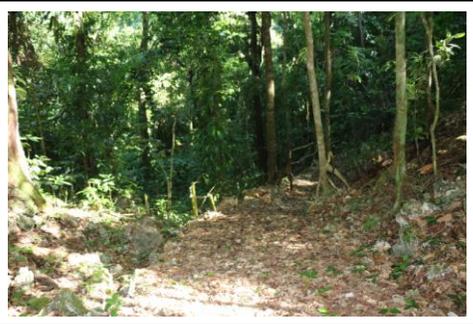
The project will utilize the entire leased private property with flat area surrounding the base of the cliff for commercial enterprise. There will be an irretrievable loss of marine habitat, particularly the sea grass community at the front of the beach due to dredging activities with motor boat.

Manual labor is used to develop the trails. Vegetations along the trails have been cleared to enlarge the trail and used as construction materials for wooden rails and rock stairs. The rocks have been uprooted or dislodged to enable alignment of the trail and have been utilized for filling of pathways and stairways.

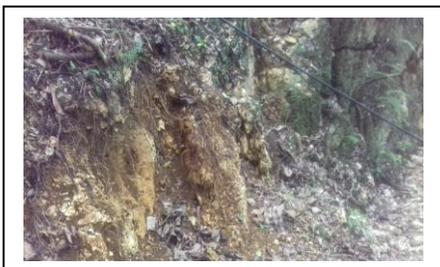
Majority of the earth moving activities have been accomplished without sedimentation plan or installation. Most of the sedimentation impact occurred during the dredging, removing the sea grass cover in-front of the beach and exposing the ocean bottom to wave actions and tidal influence.

The removal of rocks and soil along the trails also caused soil erosion but the run-offs from these activities would have just seeped into the rock crevices rather than flow away from the site. The remaining major sedimentation would occur during the earth work activities for the construction of new septic system and the staff house.

Mitigation measures recommended include: installation of EQPB approved sediment fabric to contain soil erosion in the construction areas for sewage leach field and staff house (Appendix E: Erosion and Sedimentation Control Plan). All temporary and permanent control measures should be carried out in accordance with the EQPB approved ESCP and monitored with prompt corrective actions implemented as necessary. Conduct weekly inspection of all sediment control facilities and also after each heavy rain or wind; record observations and recommendations for corrective actions. Remove sediment control infrastructures and dispose off according to EQPB requirements upon completion of earthmoving activities.

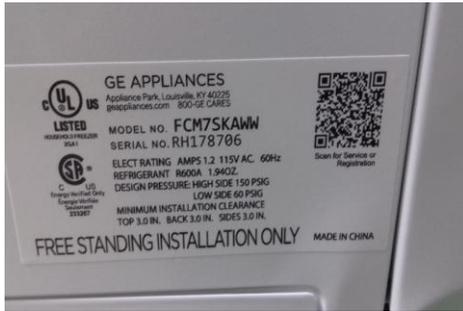
There will be one small freezer (3.5 cubic feet) in kitchen for food and drink storage. This equipment will be purchased from local hardware store ready for use and will contain about 1.94 oz. of Refrigerant R600a (see below photo for specifications).
